**FINAL APPLICATION**  
**HISTORIC LANDMARK ZONING PETITION**  
**CITY OF DENTON, TEXAS**

Site Address 322 Texas St.  
Denton, Tx 76201

## Exhibit A – Importance and Benefit to Community

## Exhibit E – Additions to original construction

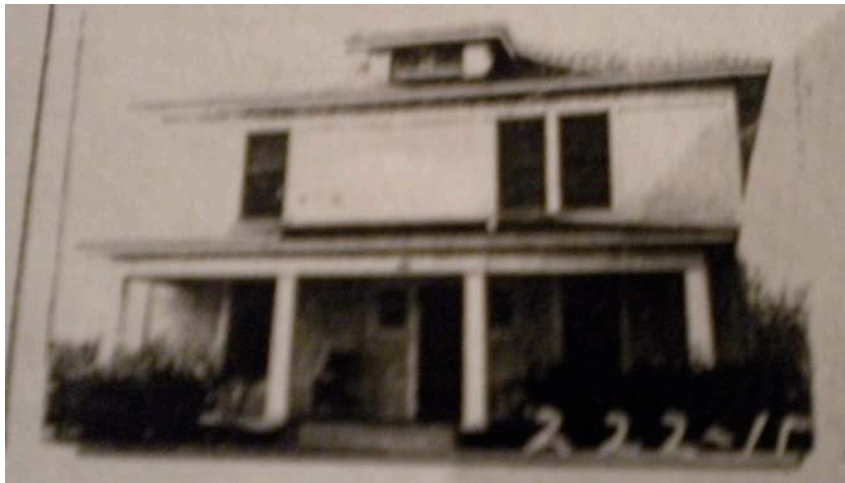
**Circa 1940s** - This is the oldest picture we have of the house – most likely dated back to the 1940s when the old tax statements (now held at the old Courthouse) were produced.

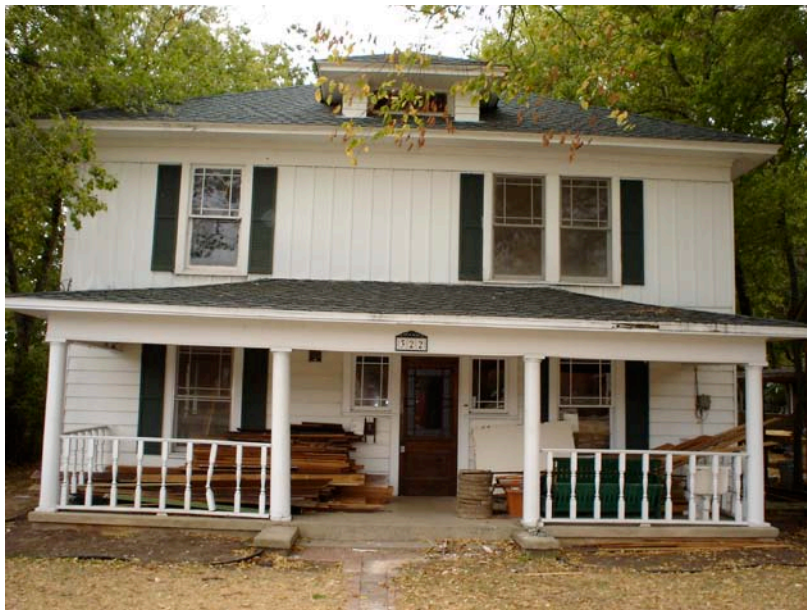
**2005** - This picture was taken when we first bought the house. It's difficult to tell from the two photos, but the most significant changes to the exterior between the two are these:

- The wooden siding and trim are now covered with aluminum siding (most likely during the Jenkins' ownership of the house)
- The porch from the 1940s picture appears to be traditional wood plank – the porch is now concrete slab.
- The pillars from the 1940s picture show square/rectangular porch posts, whereas in 2005 they are round and poorly installed (see the leaning pillar) with a wooden railing surrounding the porch.

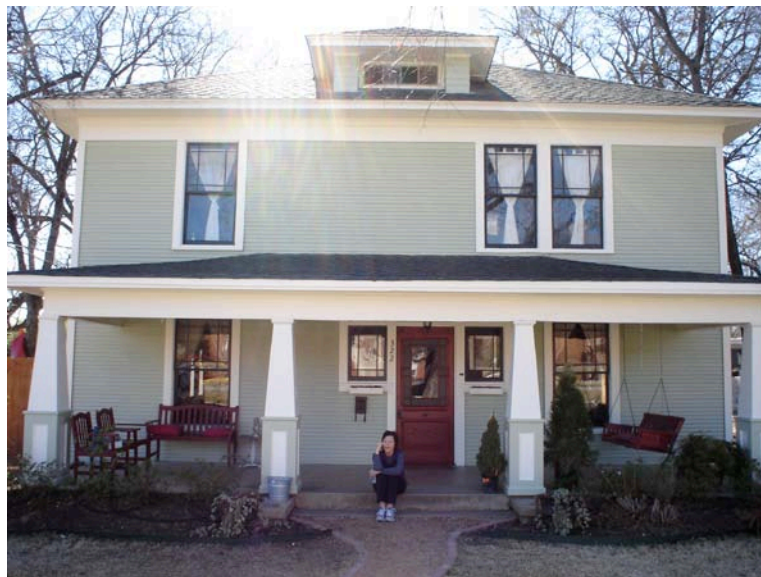
**The finished project...** we knew we needed to replace the pillars on the porch and pick a color scheme. We spent several days walking the streets of the historic Munger District in Dallas, where there are blocks of Foursquares of similar age. The pillars, though different than the ones from the 40s, gave our home a bit more grandeur while keeping with examples of the period that were found at some of the homes in Dallas. The color scheme came down to this one (Emily's pick) and a yellow scheme (my vote). A homeless gentleman who happened to wander by while we were disputing this issue was asked to break the tie and Emily got her way. At least it was a community effort.

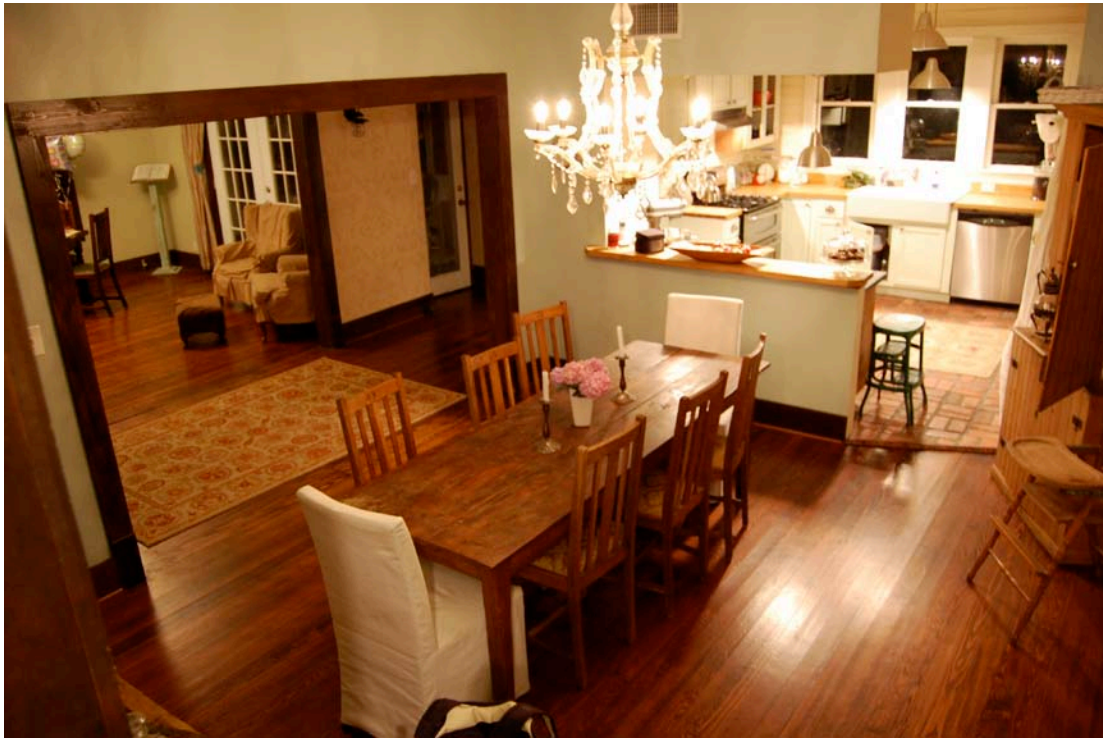
Dining Room opening up to the kitchen, hallway, and living room.

- the kitchen was completely gutted and redone and opened up to the dining room,
  - the entry to the dining room and living room was extended to give the downstairs a more open floor plan
